Gulfstream
Towers

GULFSTREAM TOWERS ASSOCIATION
33 SOUTH GULFSTREAM AVENUE

BUILDING MANUAL

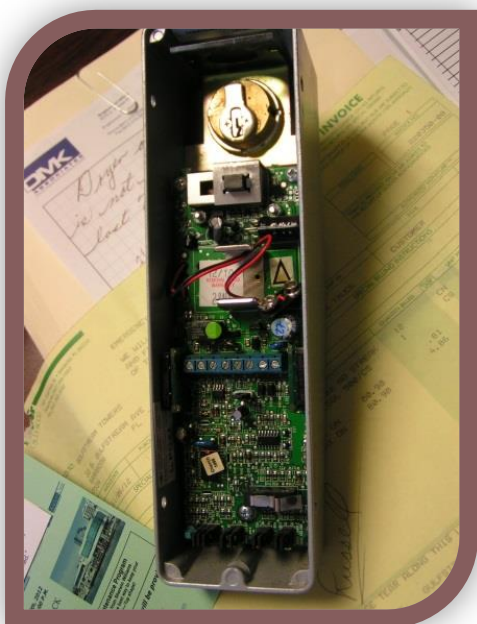
- Continuous power with the addition of an external power supply
- Multiple door monitoring permitted with built-in external reed switches
- SECURITY Door Lock and Alarm Status Indicator – The LED will indicate RED when armed.
- Entry Delay Time Options – include 15 seconds, 1 minute 15 seconds & 3 minutes 15 seconds
- Sleek model design key-activated door alarm for use on standard size and narrow stile doors
- Unauthorized use of door causes alarm to sound and activates LED indicator
- Options include continuous alarm, minute shutdown with auto reset and exit/entry delay
- Uses standard mortise cylinder
- Tamper switch supervised

- For exterior key control, optional RIM cylinder may be used
- Metallic silver finish

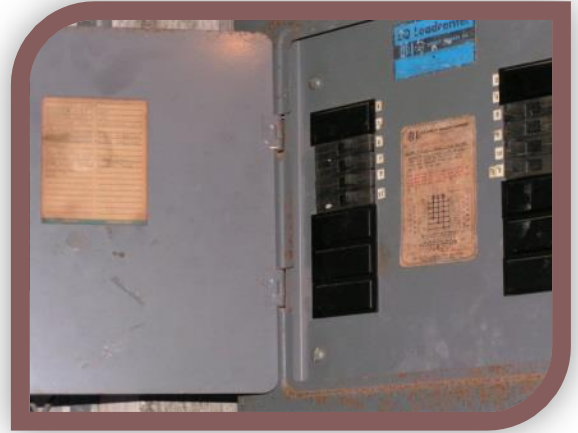
- Third floor has the generator hook-up
- Third to tenth floors also houses the air condensers for the 04, 05, 06 and 07 in the electrical rooms
- Third to tenth floors have the FPL meters and the AMP for the air conditioners for each unit.
- Second floor has two circuit breaker boxes which are for the following circuits:

NORTH CIRCUIT PANEL			
1	Water Pump Motor #1	2	Water Pump Motor #2
3	Lobby Air Conditioner	4	Dryer Laundry 6th Floor
5	Lobby Air Conditioner	6	Dryer Laundry 5th Floor
7	Pool Pump in Equip Rm	8	Dryer Laundry 4th floor
9	Light Equip Rm 3rd floor	10	Dryer Laundry 3rd floor
11	Light Equip Rm 4th floor	12	Water Heater 2nd floor
13	Light Equip Rm 5th floor	14	Air Cond Garbage Room
15	Cir Pump 2nd floor	16	Enterphone
17	Enterphone & Front entrance door lock	18	Chandelier 2nd fl / Equip lights 6th floor

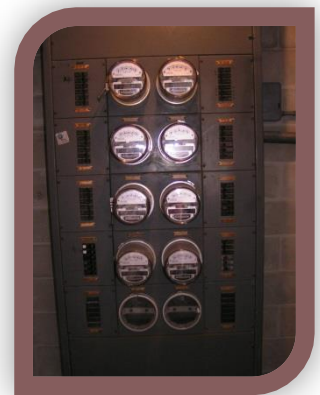
WEST CIRCUIT PANEL			
1	Garage & Patio Timers	2	Garage & Patio Timers
3	Garage & Patio Timers	4	Garage & Patio Timers
5	Garage & Patio Timers	6	Garage & Patio Timers
7	Garage & Patio Timers	8	Garage & Patio Timers
9	Pool Equipment; All lights & recept, fire pump	10	
11	Lights north storage and hall	12	Lobby restroom, trash room, office lights, office rear wall rect. 2nd floor recpt, On post by stairs ;light for fire panel
13	Lights middle lobby & mailboxes	14	Recpt left of flag pole
15	Lights pool entrance; terrace flood	16	Pool Light
17	Flood lights middle of patier lights over door	18	Shuffle board lights, recpt at pool
19	Light s& recpt South storage & Exercise room	20	201 A/C fan, heater
21	Fitness Center lights kitchen, back bedroom	22	Fitness Center lights, recpt, office storage room
23	BLANK	24	Fitness Center, conference room and library
25	Fitness Center	26	Lounge north and south walls
27	Lights, lounge over north mirror	28	Lights, lounge over wall by library

29	Receptacle, front posts near windows	30	Lights, lounge, south middle
31	Lights shower room; shower rooms & Kitchen	32	Lights & recept between shower rooms & kithcen including small storage area
33	Lights shower room hall	34	A/C Fitness Center ??
35	Washers 3 & 4th floor	36	A/C Fitness Center ??
37	Washers 5 & 6 floor	38	Stove (Fitness Center)
39	Ceiling light ladies shower A/C fitness center	40	Fitness Center Water Heater Water Heater, Ladies shower room
41	compressor	42	
43	Lobby Lights

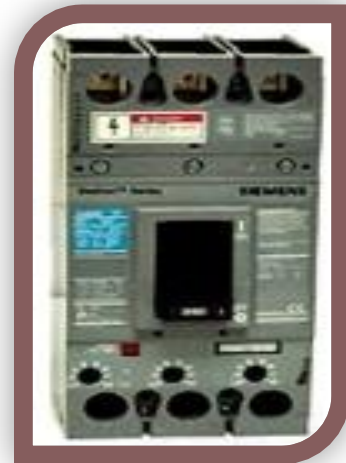
B370 Type BL Breaker by SIEMENS

B370 3 Pole Bolt-on type BL circuit breaker for Panelboard commercial light industrial use. 3 Pole Bolt on breakers can sustain heavy load demands and are specified for commercial and light industrial use. Load centers us plug-on breakers and panelboards use bolt-on type circuit breakers.

B370 Siemens 3 Pole breakers are specifically designed for industry that require constant demand for full power to equipment. These bolt-on breaker minimize arcing which causes damage to the power bus. Bolt-on breaker are more expensive than their counter part the plug-in residential style. Breaker are also switch duty rated and rated for use with air conditioning, heating and lighting.

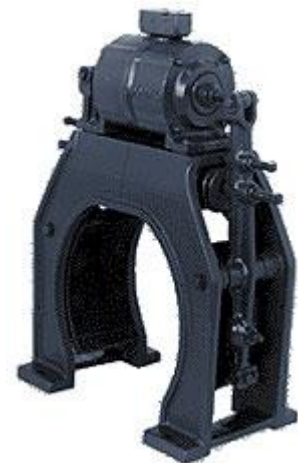
Solid State Drive Units Brake Assembly

The brake is a spring loaded clamping device that prevents the elevator from moving when the car is at rest and no power is applied to the hoistway motor. When considering a modernization and the hoist machine warrants retention, then the brake type and condition should be assessed for refurbishment. Refurbishment normally includes new coil, pins, core, sleeve, pads, and springs, and a thorough cleaning, painting and testing. If it does not warrant retention a new replacement brake can be added to the existing machine. Resurfacing or replacement of the drum can be required also. If a new machine is being installed, it is most cost effective to purchase a new brake as part of the new machine assembly which is installed and test at the factory prior to delivery.

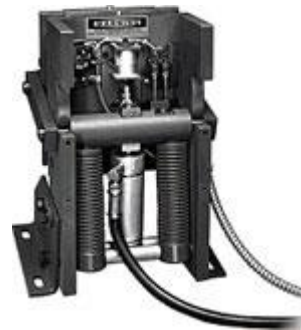
Rope Brake

In recent years, safety codes have introduced a need for protection against injuries caused by elevator cars leaving the floor with the doors open and over-speeding in the up direction. The rope Brake is a device used to grab elevator suspension ropes to stop the elevator in the event of a mechanical or electrical failure. It activates if an ascending elevator over-speeds in the up direction and also if the elevator leaves the floor with the doors opened. Though not required in all locations, it is common to consider adding a rope brake device when modernizing your elevators. Special fit considerations are required before a brake can be added to an existing machine. We will assess conditions and advise on the feasibility of adding a rope brake as part of our modernization survey for you.

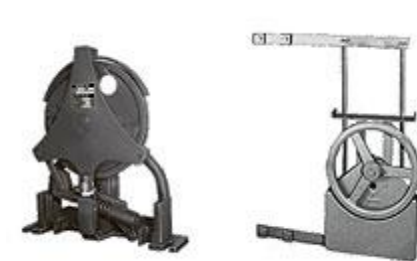
Over Speed Governor/Governor Rope Tension Sheave Assembly

The **over speed governor** is a speed monitoring device on cable equipped elevators that triggers the safety when the elevator over-speeds. When planning a modernization these devices can be retained provided they are properly equipped to meet current code requirements. Should they not comply with current code requirements replacement will be necessary.

The governor rope tension sheave is required to keep proper tension on the governor cable during operation of the elevator. When planning a modernization this device can normally be retained unless conditions exist that require its replacement. We will include inspection of your governor tension sheave assembly

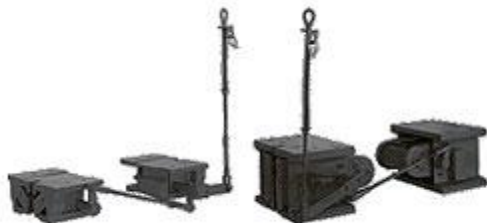
The safety is a device on the car or counterweight that will stop the car or counterweight and keep the elevator from falling in case of overspeed, free-fall, or rope stretch. When considering a modernization in most cases the safeties can be reused. We normally recommend cleaning and adjusting them. In cases of very old elevators there are cases where the existing safeties can not be reused as they are out dated and parts are obsolete.

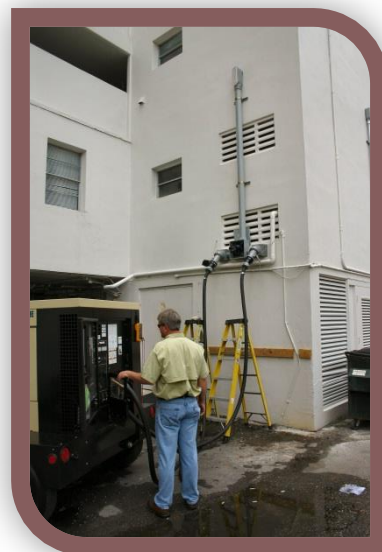
GENERATOR (wired to service fire pump, both elevators, second floor, and lights in both stairways)

- A. Verbal lease agreement with Statewide, Bob Benson, for use during emergencies
- B. 3 – 200 amp
- C. 1 – 100 amp 3 phase manual transfer switches wired deownt o a multi tap buss bar in a weather proof wire way.
- D. Generator Rental Pricing:
 - i. 56 KW generator
 - \$1,440.00 per week
 - \$4,320.00 per month
 - ii. 80 KW
 - \$1,663.00 per week \$4,989.00 per month
 - iii. 100 KW Generator
 - \$1,764.00 per week
 - \$5,290.00 per month

1. A hard core set connection from the generator to the temporary system via two (2) 200 ampere cord sets to minimize the possibility of reverse rotation of the 3 phase motors. Simply put, any wrong combination of lines A, B, or C when connecting the temporary generator to the system will result in the motors running in the wrong direction. This cord set installation makes this virtually impossible to incorrectly connect the generator unless the individual make the connection is careless.
2. Two cord sets are required since each is only capable of carrying 200 amperes. If a larger generator is brought in the second cord will be necessary to handle the load. Both cords will be hooked up at any time a generator is brought on-line.

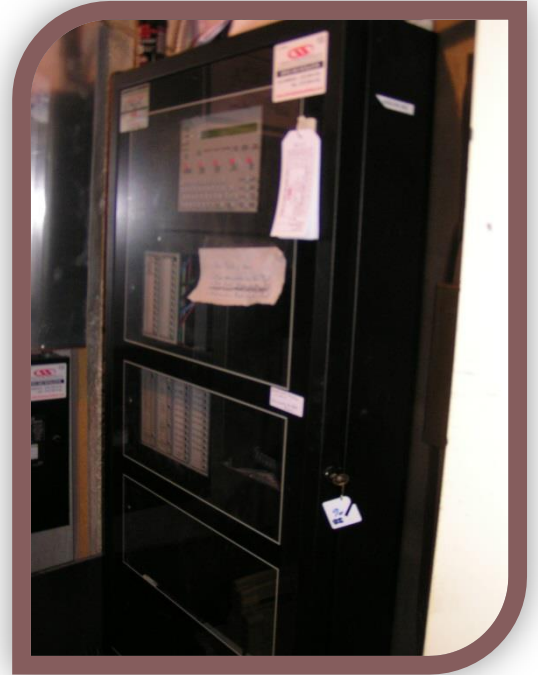
FIRE ALARM PANEL:

- a. Installed by Critical System Solutions in 2010 for \$61,600
- b. Power Source: Fire alarm panels are required to have a primary (A/C) and secondary (battery) backup power supply. Both of the batteries were replaced by Piper Fire in May 2013. It is mandatory to change the batteries every five years.
- c. The fire alarm equipment is a proprietary system, Notifier 640/E by Honeywell AA-series Analog Audio Amplifiers AA-30, AA-100, and AA-120. The monitoring company is Rapid Response; via Critical System Solutions.
Email: FireSystems.TechPubs@honeywell.com
- d. Fire alarm panels have two means of communication if required to be monitored by a central monitoring station.
 - Two separate phone lines: Primary line should not be a 'voice over IP'; must be a copper phone line.
 - Two wireless or radio signal paths
 - Acceptable signal strength to two cell towers

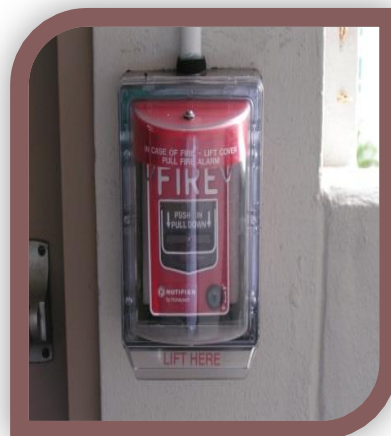
PULL STATIONS

Manual fire alarm boxes to be used only for fire alarm initiating purposes. We have 22 onsite.

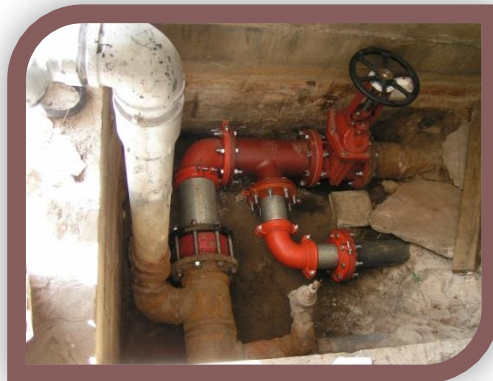
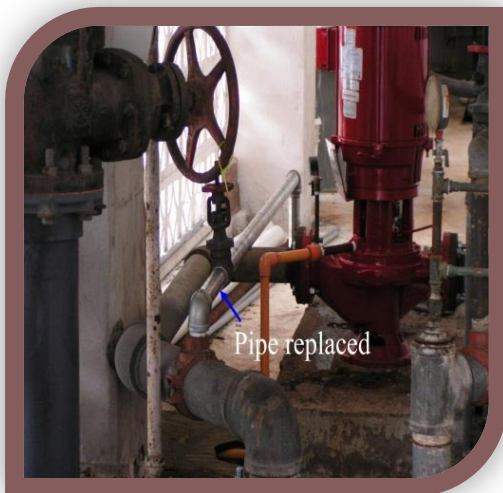
Our system is a straight pipe riser wet pipe **fire sprinkler system**. It is the most reliable, because it is simple, with the only operating components being the automatic sprinklers and (commonly, but not always) the automatic alarm check valve. An automatic water supply provides water under pressure to the system piping.

A wet system, as defined in NFPA 13, is a sprinkler system employing automatic sprinklers attached to a piping system containing water and connected to a water supply so that water discharges immediately from sprinklers opened by the heat from a fire². A wet system is used in areas that can be maintained above 40° F (4° C). The sprinkler riser is the bridge between the underground and interior piping. This is the point where we supply the cross mains, feed mains and branch piping that make up the wet system piping network. It is at the sprinkler riser where we begin to make decisions on the components needed. There are two typical types of wet system sprinkler risers to choose from; a riser

alarm check valve assembly or a ported check valve with a flow indicator.

We use an alarm check valve on the riser to lock water pressure into the system and prevent the water in the sprinkler piping from traveling back into the water supply. Trim piping around the check valve is used to activate an alarm, which can be a mechanical or electrical device, during a water flow condition. The alarm check valve is equipped with an inlet, an outlet and multiple tapped bosses.

Two of these bosses are for pressure gauges that show the supply side and the system side water pressure. Two are located in the back of the valve for a bypass line; this is for low flow conditions with less than one sprinkler and prevents the clapper from opening unnecessarily. The other two bosses are for a main drain and an alarm line port. The main drain is located so that the entire system above the alarm valve clapper can be drained. The alarm line is connected to trim piping, continuing on to the alarm devices. When a sprinkler operates, water

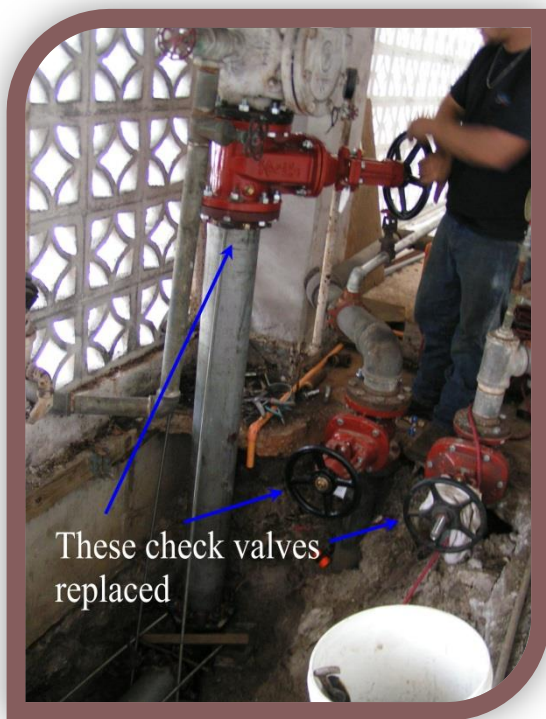
flows through the check valve and pushes the clapper open. Water then enters into the alarm line and will activate an alarm pressure switch or a water motor gong, sending a signal that there is water flowing in the system.

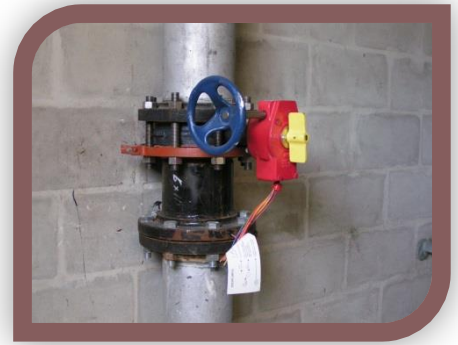
A **wet pipe sprinkler system** is a sprinkler system employing automatic sprinkler heads attached to a piping system containing water and connected to a water supply so that water discharges immediately from sprinklers opened by heat from a fire.

Each sprinkler is activated individually when it is heated to its design temperature. Most sprinklers discharge approximately 20-25 gallons per minute (gpm), depending on the system design. Sprinklers for special applications are designed to discharge up to 100 gpm.

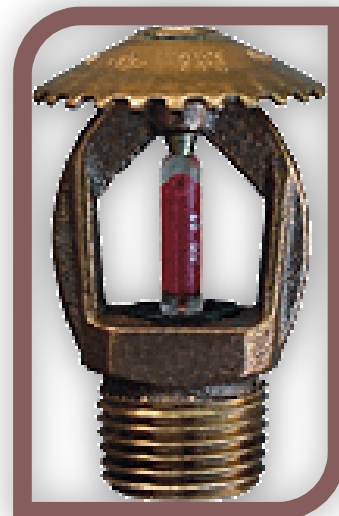
Model 9105 ????: currently straight brass nickel coated upright sprinkler head

- **Base:** 1/2" NPT
- **Temperature:** 135°F, 155°, 175°, 200° or 286°, color-coded bulbs indicate temperature
- **Orifice:** 3/8", 7/16", 1/2" or 17/32"
- **Type:** Standard Response, Quick Response or Early Suppression Fast Response (E.S.F.R.)

It is used in automatic fire protection systems to distribute water spray from fixed locations; Garage, Storage Units (north and south end of the building), Trash room and _____

Heads also have a date stamp on them, Garage has 192 heads, Storage units have _____, other _____. Original heads were wax coated.

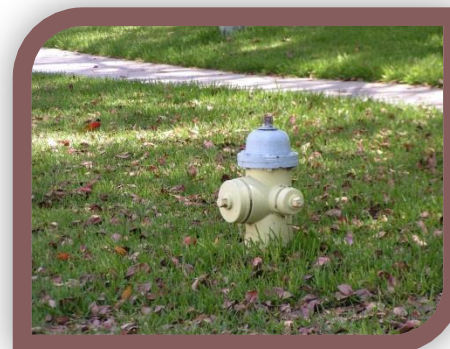
Fire hydrant caps are painted different colors to allow firefighters to quickly identify the flow rate of any fire hydrant. Knowing the flow rate of a fire hydrant tells them how much water it can provide for firefighting operations. The four basic colors of fire hydrants and their respective flow rates are listed below.

- Red fire hydrants have a flow rate under 500 gallons per minute.
- Yellow fire hydrants have a flow rate between 500 and 999 gallons per minute.
- Green fire hydrants have a flow rate between 1000 and 1499 gallons per minute.
- **Blue or light blue fire hydrants have a flow rate of 1500 gallons per minute or higher.**

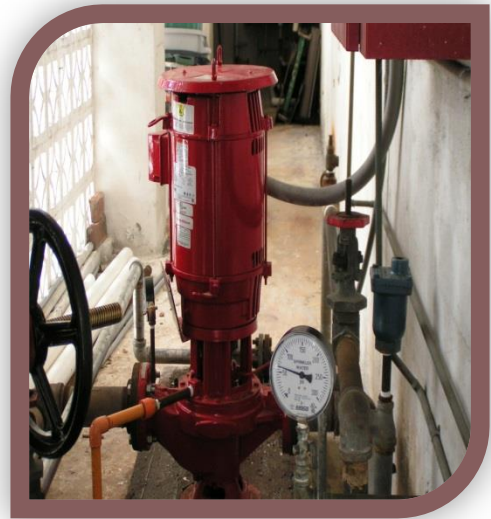
JOCKEY PUMP CONTROLLER

- Jockey Booster Pump; Aurora; serial no: 02-407349/AE91-4; model no. 1.25.1.25; AD20; US Electric Motors; Catalog no. FF25S1XV, FR; 256JP; Type DF1; Labour Control No. 55XL
- Jockey Pump for sprinklers: This keeps the pressure even.

- Pressure is set at 70 - 75
- Model: BVL56T34D5830 A P
- HZ 60
- HP 1
- RPM 3450
- Volt: 208-230 / 460
- Light bulb;
- Controller: Limited Service Controller - Firetrol, FTA catalog #FTA 750-AA25H; model no. PMC-1-3-20; serial no. 91384 Type ABB; Part no. B 533019—7
 - Manual is in the binder

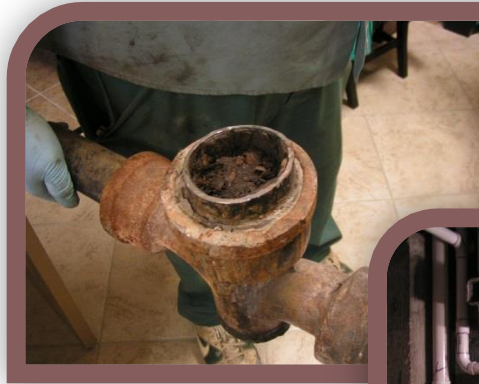
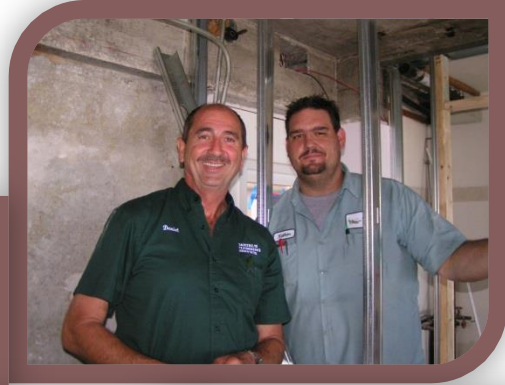
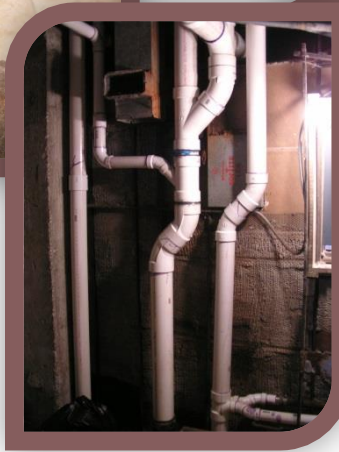
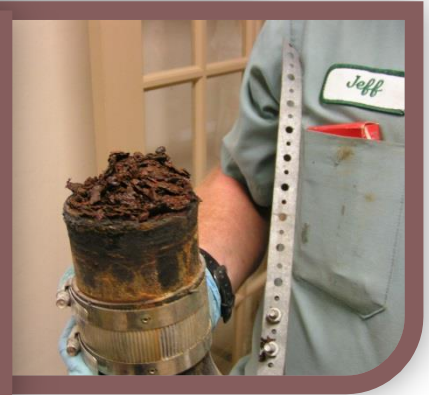
Photos of replaced cast iron by Daniels Plumbing:

STACKS THAT HAVE HAD THE CAST IRON REPLACED WITH PVC PIPES

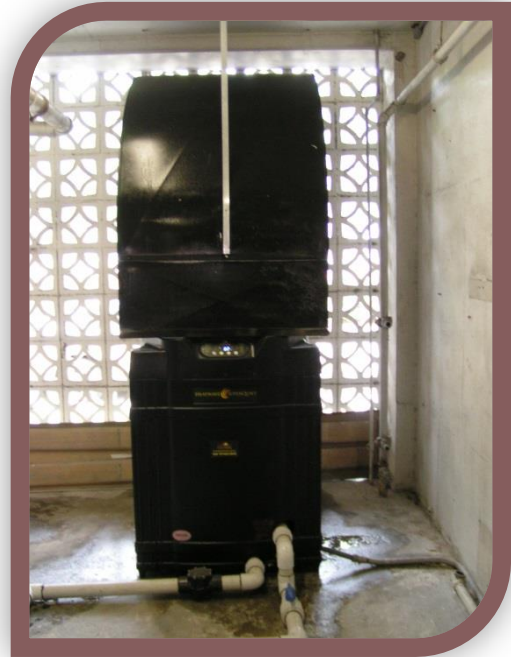
7. **AQUACAL SQ175** ELECTRIC POOL HEATER SPECS:

BTU's	143,000
COP	6.5
Water Flow	30-70 gpm
Kilowatt Input	6.4
Voltage/Hz/Phase	208v-230v / 60 hz / 1 phase
Min Circuit Ampacity	41.1
Min / Max Fuses Size	50 / 60
Weight	425 lbs.
Size (LxWxH)	37" x 33.8" x 45"
Decibels	55 dB

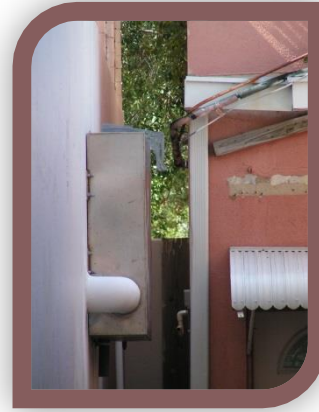
POOL COLLECTOR TANK

June 10, 2009, water recirculating collector tank was installed by Crest Engineering for \$3,500.00

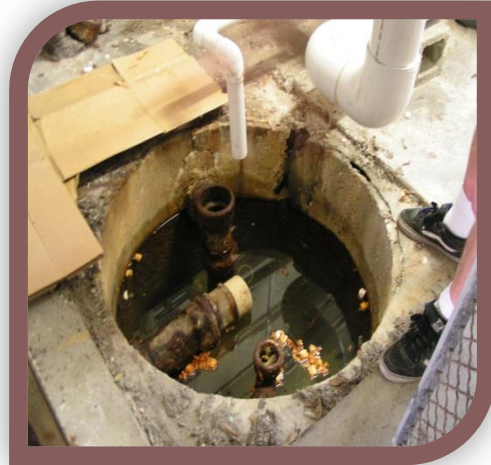
POOL PIT

This is the pool drainage overflow for the pool area and was repaired in 2012

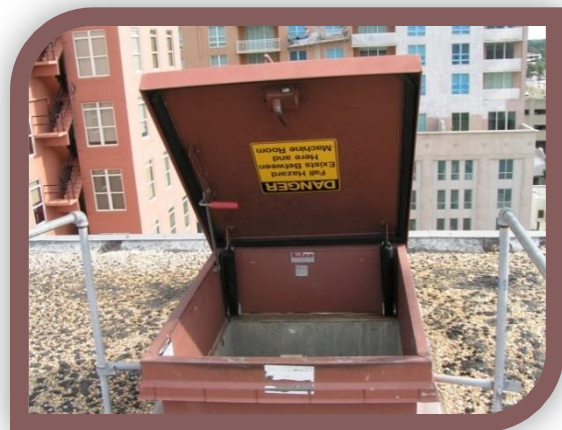
Two roof access hatches; north and south

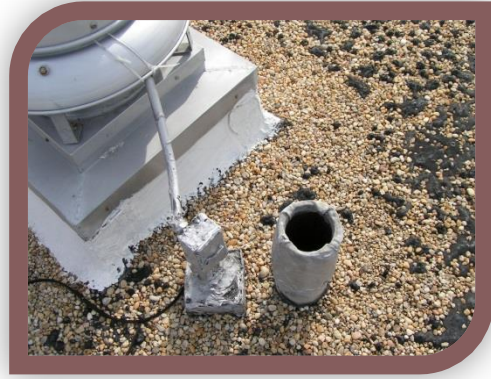
Direct-Drive Downblast Centrifugal Roof Ventilators

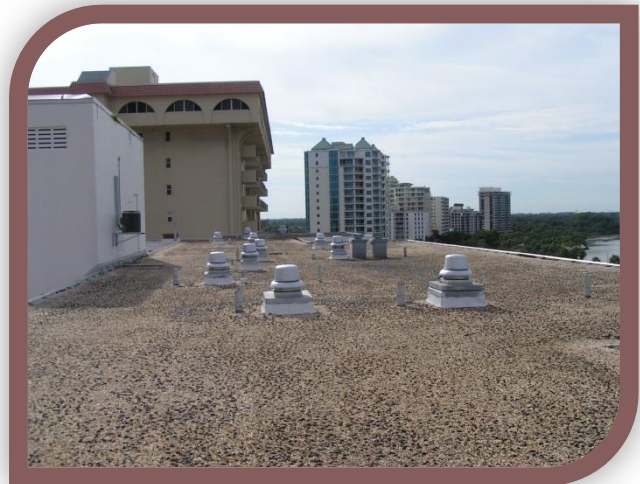
Two fireplace flues on the roof.

One was removed with 1004/5 renovated in 2012.

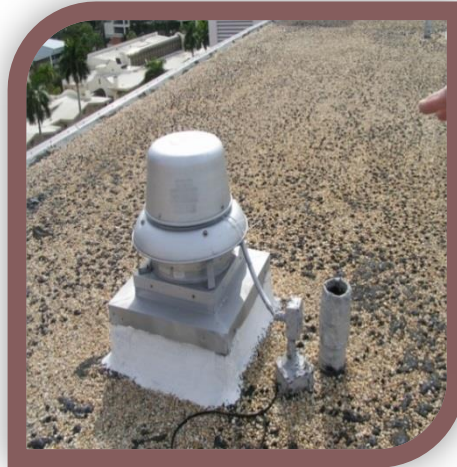
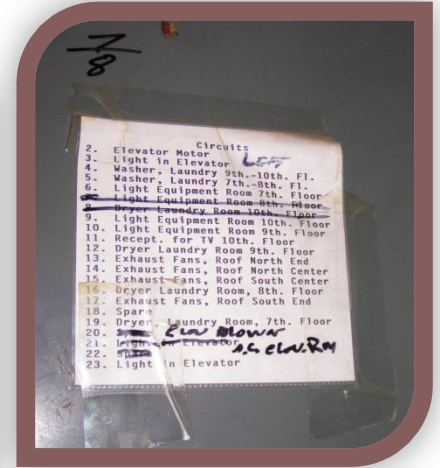
ROOF EXHAUST VENTILATOR

Exhaust Fans on Roof: Circuit breakers are located behind laundry on 10th floor. There are 5 breakers. There are 16 vents located on the roof; Two large, seven bath and seven kitchen (these have thermostats on and are set at 65 degrees).

Electro Mechanical services all vents.

EXHAUST FANS ON THE ROOF					GRAINGER: 941-753-3904				
NORTH					ELECTRO MECHANICAL SOUTH: 342-9111				
CIRCUIT BREAKERS in ELECTRICAL ROOM ON 10TH FLOOR ~ 5 ZONES									
Fan #	LOCATION	STACK	MOTOR	STATUS	Fan #	LOCATION	STACK	MOTOR	STATUS
1-A	Bath	"01"	1/8 HP-1140 rpm		8-J	04 - Bath	"05"	Grainger Dayton 3M574 \$108.55 Motor 4.4 In, 1/10 HP, 1550v, OpAO, Stud	Replaced on 8/3/2012
2-B	Bath	"02"	1/15 HP-1550 rpm		9-H	Bath	"06"	1/15 HP-1550 rpm	
3-B+	Kitchen	"02"	1/15 HP-1550 rpm		10-J+	Kitchen	"06"	1/15 HP-1550 rpm	
4-A+	Kitchen	"03"	1/8 HP-1140 rpm		11-B+	Kitchen	"07"	1/15 HP-1550 rpm	
5-F	Bath	"03"	1/12 HP-860 rpm		12-A	Bath	"06"		5/29/2012 new motor
6-E	Bath	"04"	1/12 HP- 860 rpm		13-A	Bath	"08"	1/8 HP-1550 rpm	
7	Bath	"04"			14-B+	Kitchen	"08"		5/29/2012 new motor
					15-B	Bath	"09"	1/15 HP-1550 rpm	
					16-A	Bath	"09"	Grainger Marathon: Part No. 1309.11M.10 Model: 8VE48A1101882B P HZ: 60 HP; 1/4 RPM 1075; Volt 115/208-230	Replaced by Electro Mechanical on 2/22/2013

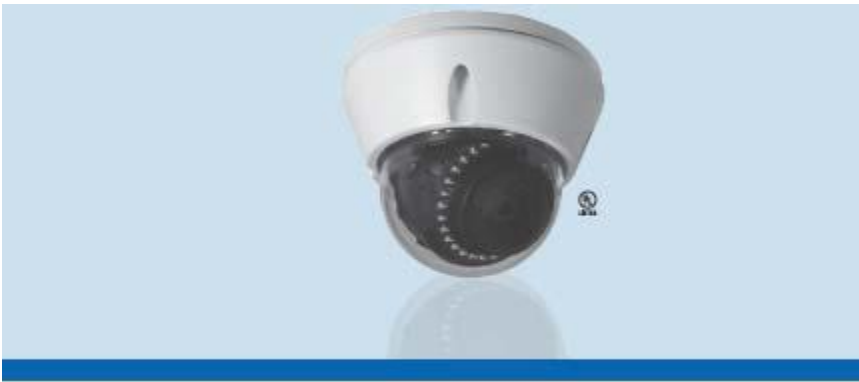
Vandal Dome, TRUE Day/Night, High Resolution 600TVL with Digital-WDR

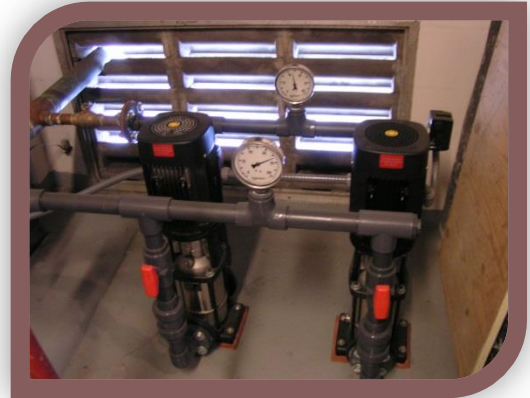
- a. Contract with KW Water Pump {Kendall Wilson}
- b. 2 2 h/p, CR5-6.5 stage Grundfos vertical multistage stainless steel pumps (1 year warranty from 3/31/2011)
- c. 2 2 h/p Yaskawa frequency drives (5 year warranty from 3/31/2011)
- d. 2 100 pressure transducers

Pressure is set at 76 lbs and the second pump comes on when demand is over 78 lbs (usually 10 lbs per floor)
